CHARACTERIZATION OF IR WINDOWS SEMIANNUAL TECHNICAL REPORT

J. S. HAGGERTY, E. T. PETERS

SEMIANNUAL TECHNICAL REPORT

Program Title: Characterization of IR Windows

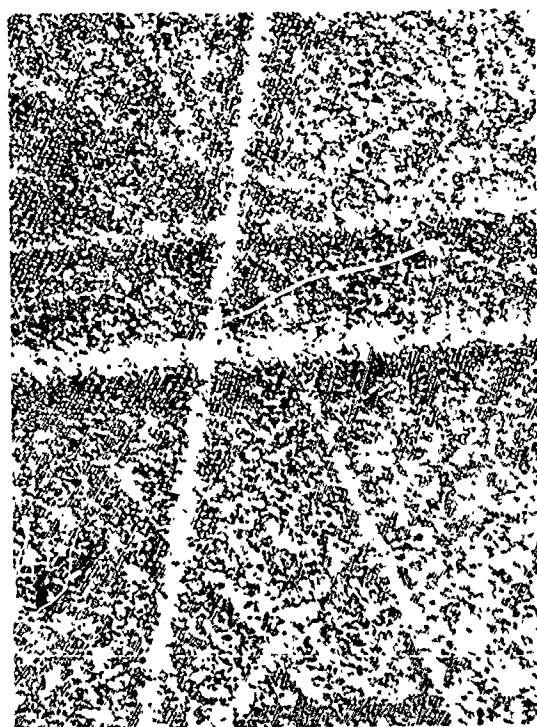
FIGURE 1 BACK REFLECTION TOPOGRAPHIC IMAGES FROM (111) GaAs,
CuK α RADIATION, TRANSMITTED LIGHT (a), (b), AND
(d) 35 KV TUBE VOLTAGE, (c) 20 KV TUBE VOLTAGE

Several exposures were made to determine the effect of tube voltage on resolution. For this purpose, a (422) reflection from GaAs was limited

by slits to an area of about 1/8 x 1/4 inch. Exposures were made at 35kV and 20kV tube voltage. The crystal was then rocked off peak, and an adjacent set of exposures was made, representing background scatter from the sample. Representative photographs from this series are presented in Figure 1. Individual photographic emulsion "grains" can just be observed in the background images at 375X and are more clearly presented at 865X. For the most part, these grains have an apparent size of 0.5 to 1 μ m, or about three to seven times larger than the mean AgBr particle size. This is apparently the result of an X-ray photon causing the sensitization of several AgBr particles within a small volume rather than continuing activation to a single particle. There are some clusters of grains that are larger, i.e., 2 to 3 μ m in extent, indicated by arrows marked "a". The presence of an isotropic defect, such as a spherical precipitate, would therefore not be clearly identified unless it generated a strain field at least 5 μ m in extent. Lineal defects, however, such as the polishing scratches shown in the left hand photographs, are clearly discernible at high magnification, as shown in Figure 1c. Even with an apparent limit in plate resolution of a few microns, these very fine, two-dimensional features, some of which are indicated by arrows marked "b", can be clearly observed. Figure 1c, obtained with a 20kV X-ray beam, is observed to exhibit the same resolution characteristics as the images obtained with a 35kV beam. The increased number of higher energy photons which are scattered at 35kV have no observed deleterious effect on resolution, thus permitting shorter exposure times.

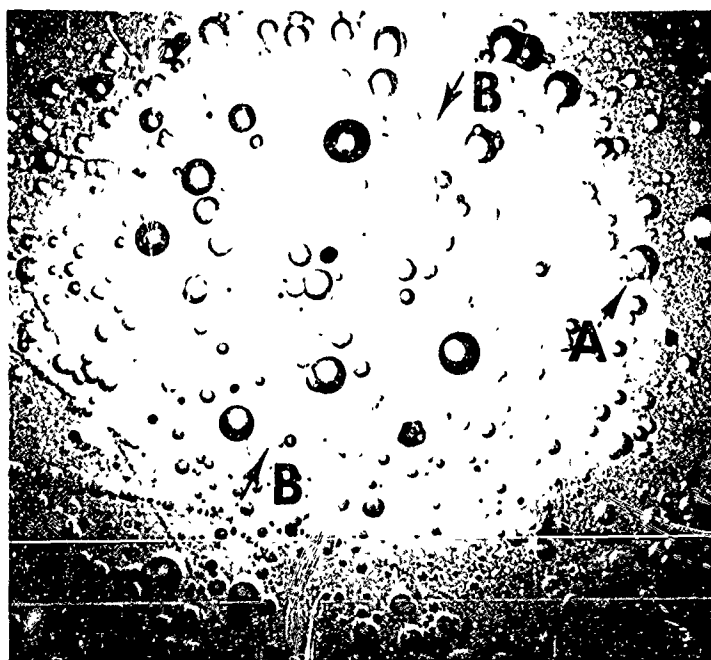
FIGURE 3 PHOTOGRAPHS OF GaAs SURFACE AFTER ION THINNING
(a) OPTICAL MICROSCOPY (b) SCANNING ELECTRON
MICROSCOPY

Initial characterization included visual examination of the surfaces by optical and scanning electron microscopy. In all cases, the ion thinned samples contained numerous shallow craters of varying diameter, as shown in Figure 3. Impingement of craters occurred frequently; in some cases, impingement was limited to two or three adjacent craters (labeled A in Figure 3); whereas in other cases, impingement was strung out along a line (labeled B). These same features are shown at higher magnification in Figure 4a. The edge of the sample, shown in Figure 4b, is apparently influenced by deposition and resputtering of copper from the heat sink substrate, resulting in the characteristic cone structures. Occasionally cones were observed in craters away from the sample edge.

At present, we have no understanding of why craters form. They are apparently the result of preferential sputtering at specific points, which then widen spherically. They become evident (25X optical microscopy) only after approximately 8 μ m of material has been sputtered off. One can speculate that craters originate at point defects, i.e., regions of high strain (such as dislocation cores) or chemical inhomogeneity (precipitates). Were this the case, the largest craters would be expected to be the earliest formed (that is, nearest to the original surface). However, the linear arrays of craters, which are reminiscent of polishing scratches on the original surface, are generally formed from fairly small diameter craters. Rather than pursue a thorough understanding of the ion thinning process at this time, we intend to compare the distribution of surface craters to other structural features that are observed by X-ray topography, infrared microscopy and electron microscopy. Consequently, surface photographs of crater distributions were obtained from three of the thinned GaAs slices at several magnifications. These photographs will be presented together with the X-ray topographic data.

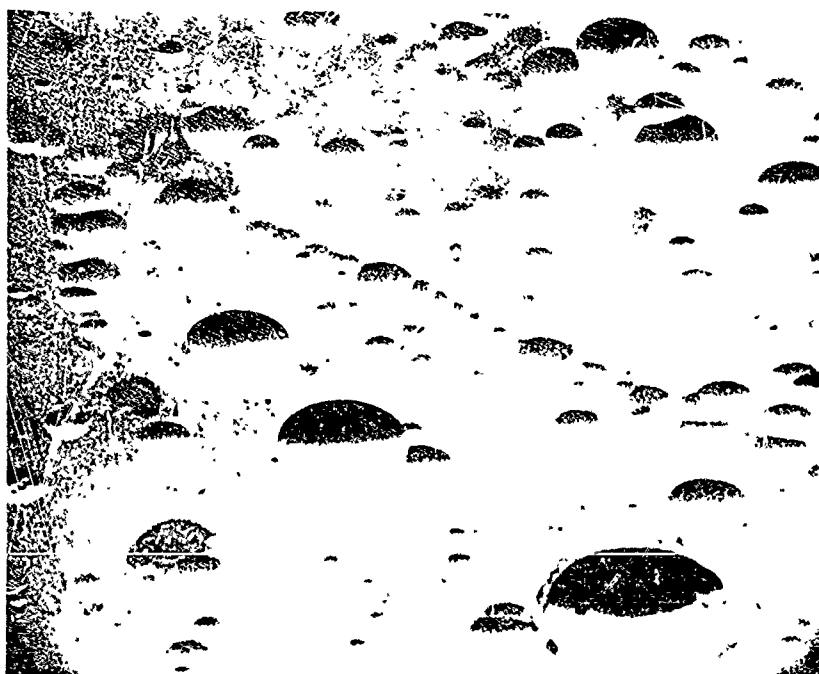
FIGURE 4 SCANNING ELECTRON MICROGRAPHS OF GaAs SURFACE
AFTER ION THINNING (a) CENTER OF SAMPLE
(b) EDGE OF SAMPLE

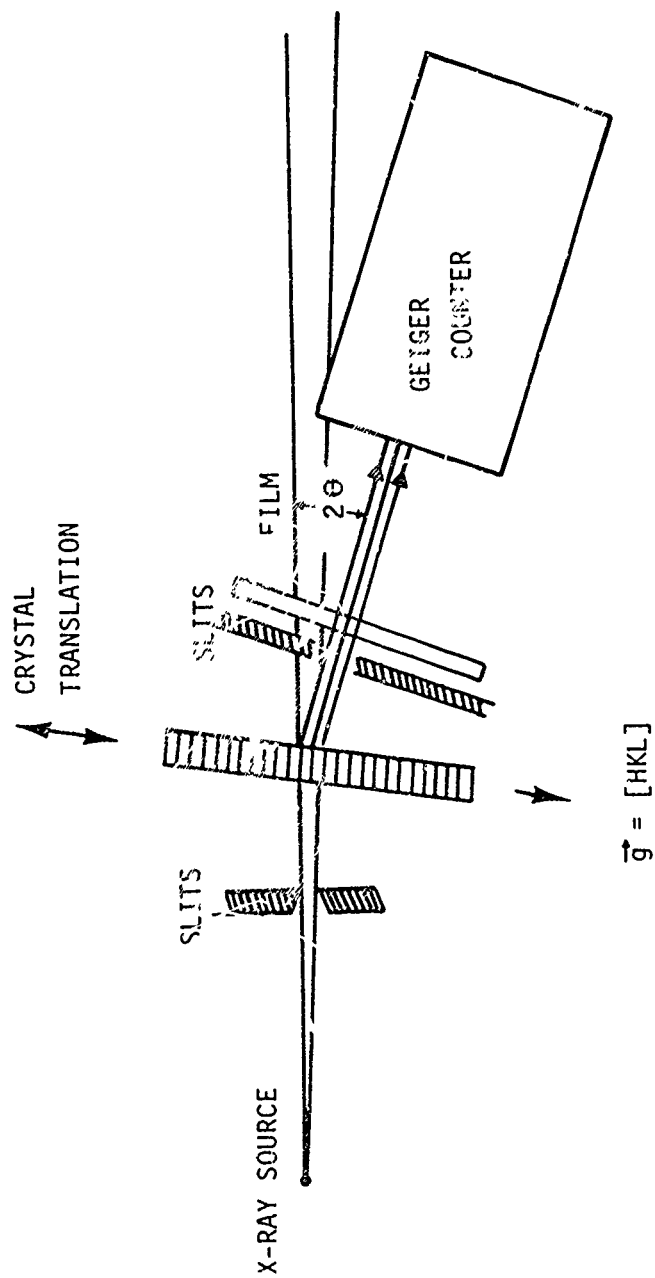
FIGURE 5 SCHEMATIC SKETCH SHOWING THE SCANNING
TRANSMISSION TOPOGRAPH GEOMETRY

These slices were employed for (440) back reflection and (220) transmission X-ray topographs. The back reflection patterns were obtained by the experimental procedure presented in the last report,⁽¹⁾ and transmission patterns taken with AgK_α radiation, utilized the geometry presented in Figure 5.

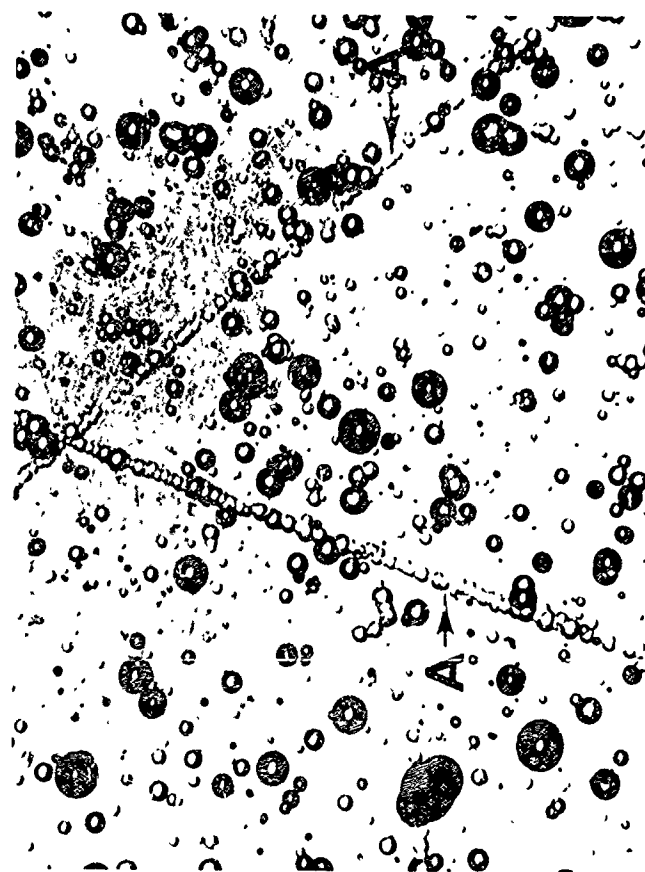
FIGURE 6 OPTICAL AND TRANSMISSION X-RAY TOPOGRAPHS OF (111)-ORIENTED THIN SECTION OF GaAs FROM SAMPLE NO. 1860B

Optical and transmission X-ray topographs are presented at several magnifications in Figure 6. The low magnification optical image displays many lines, designated by A, is shown at several magnifications. It is noted at high magnification that the line set actually corresponds to quite small, connected craters. Individual craters range in size from sub-micron to about 100 microns in extent.

Other than one deep polishing mark, labeled B in the low magnification photograph and topograph, there are no obvious similarities in structure between the optical and X-ray images. The foreshortening of the X-ray image in the horizontal direction results from the diffraction geometry.) At low magnification, the X-ray image shows substantial structure reminiscent of the previously presented back reflection topographs.⁽¹⁾ The apparent change in film density across the line marked C is the result of a composite exposure which was required to image the entire crystal. Other variations in density are the result of severe inhomogeneous lattice strain. At higher magnification (22X), the structure is observed to consist of very small cells. Even at quite high magnification (150X), the structure is so dense that it is impossible to resolve individual defect features.

The observed structure is typical of that resulting from breakdown of a planar solid-liquid solidification interface to a cellular interface. Cell walls are sinks for impurities as well as dislocations causing these regions to be highly strained compared to the interior of the cells. This is the source of the enhanced X-ray diffraction contrast.
